The Secretary of the Interior's Standards  
for the Treatment of Historic Properties

with Guidelines for  
Preserving, Rehabilitating  
Restoring & Reconstructing  
Historic Buildings

Kay D. Weeks and Anne E. Grimmer

U.S. Department of the Interior  
National Park Service  
Cultural Resource Stewardship and Partnerships  
Heritage Preservation Services  
Washington, D.C.  
1995

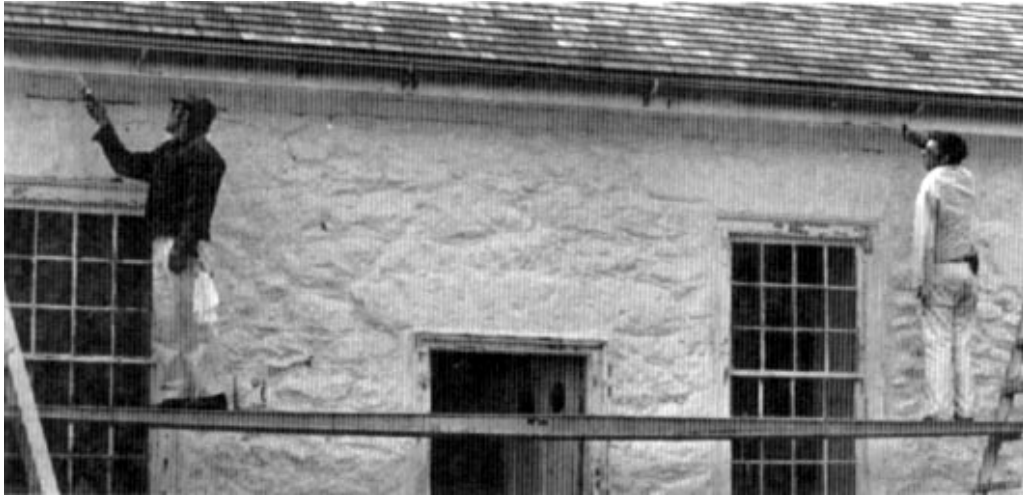
*Adequate protection and maintenance of a historic building is an ongoing commitment. Here, two workers are priming and repainting exterior stone and wood trim. If surface treatments are neglected, more extensive repair and replacement will be required. Each loss further undermines a building's historic integrity.*

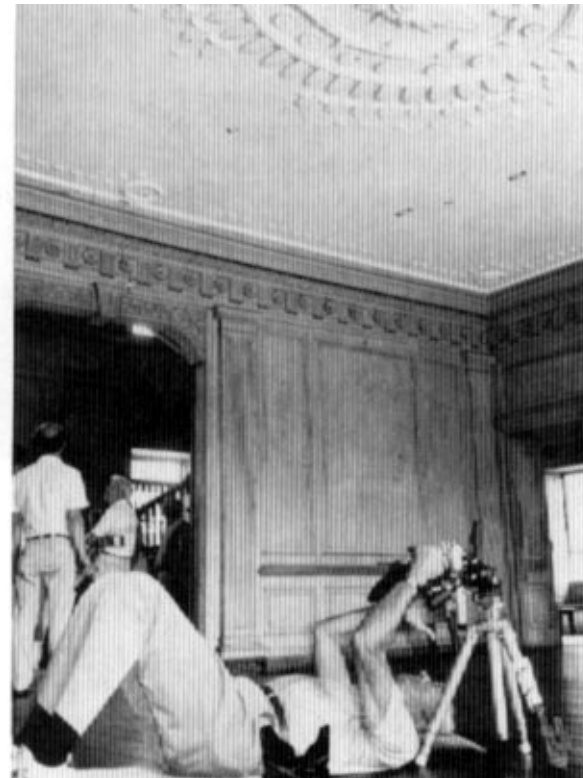
*Careful documentation of a building's physical condition is the critical first step in determining an appropriate level of intervention. (a) This may include relating the historical research to existing materials and features; or (b) documenting a particular problem such as this cracked ceiling. Photo (a): Jean E. Travers; Photo (b): Lee H. Nelson, FAIA.*

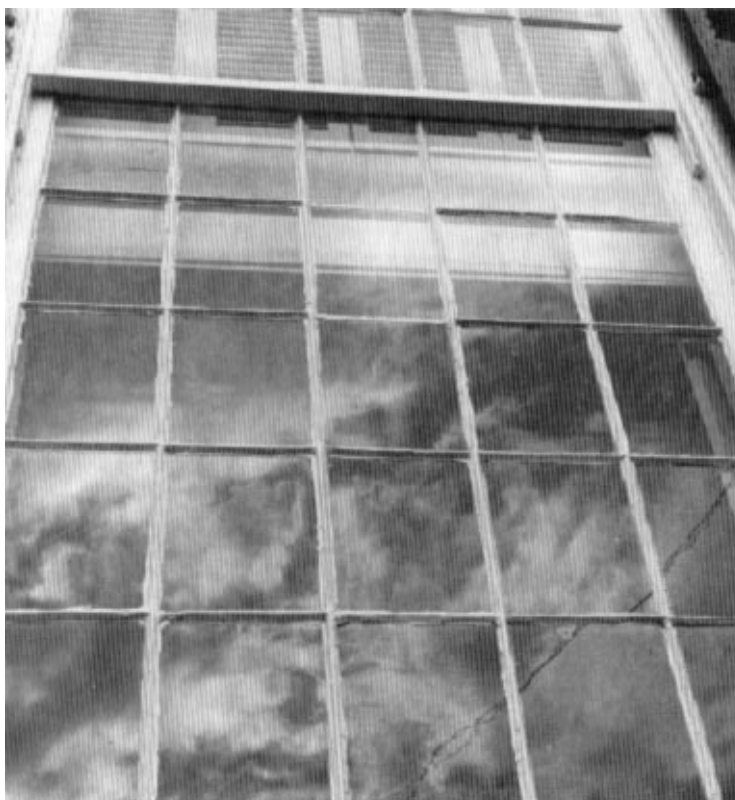
*According to the Standards for Rehabilitation, existing historic materials should be protected, maintained and repaired. In an exemplary project, the windows and shutters of this historic residence were carefully preserved.*

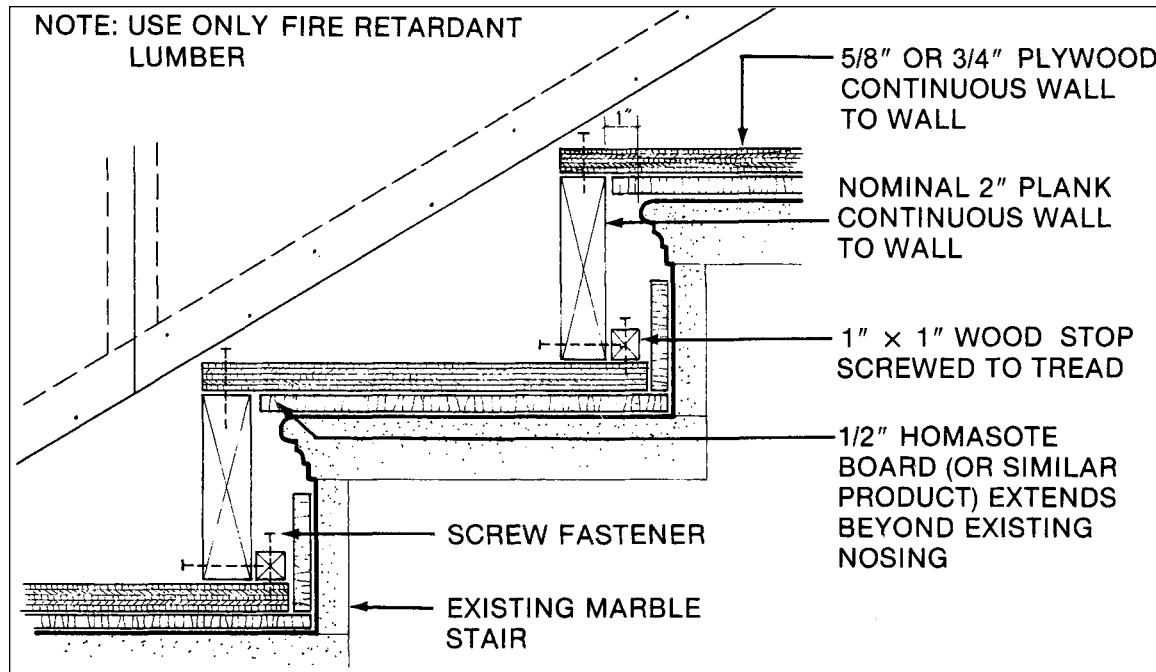
*Historic features that characterize a building should always be protected from damage during rehabilitation work. The drawing shows how a resilient, temporary stair covering was applied over the existing marble staircase. Drawing: National Park Service staff, based on material originally prepared by Emery Roth and Sons, P.C.*

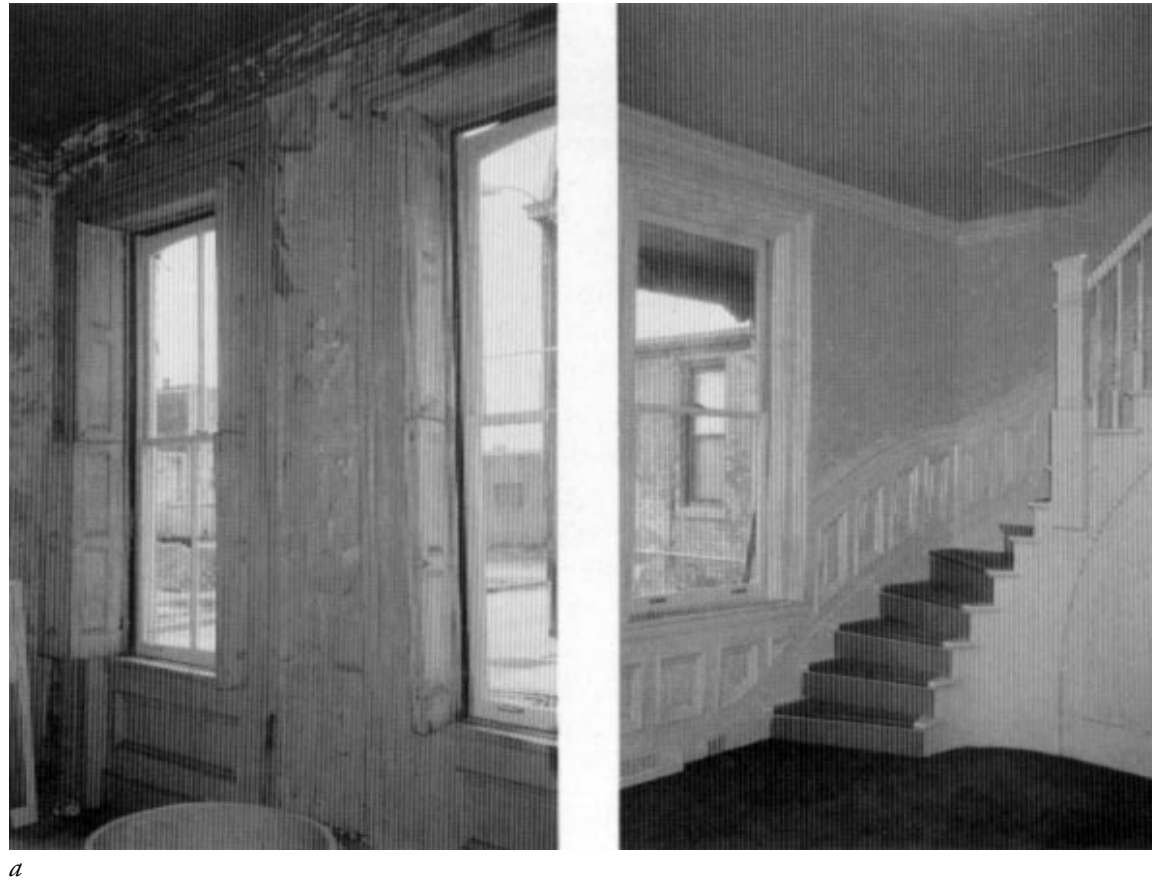
Rehabilitating historic dwelling units often includes some level of lead-paint hazard abatement. Whenever lead-base paint begins to peel, chip, craze, or otherwise comes loose (a), it should be removed in a manner that protects the worker as well as the immediate environment. In this example (b), the deteriorating lead-paint was removed throughout the apartment building and a compatible primer and finish paint applied. Photos: Sharon C. Park, AIA.

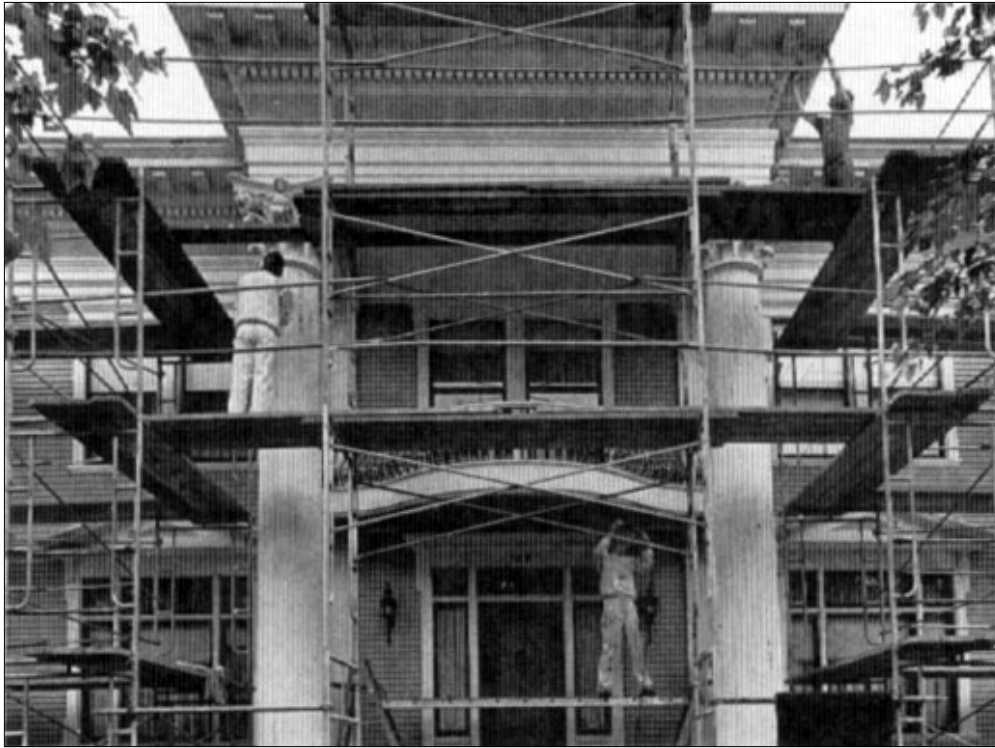
*Ongoing work at this house focuses on the maintenance and repair of exterior wood features from the restoration period. After scraping and sanding, the wood was painted in colors documented to the Restoration period. Photo: ©Mary Randlett, 1992.*

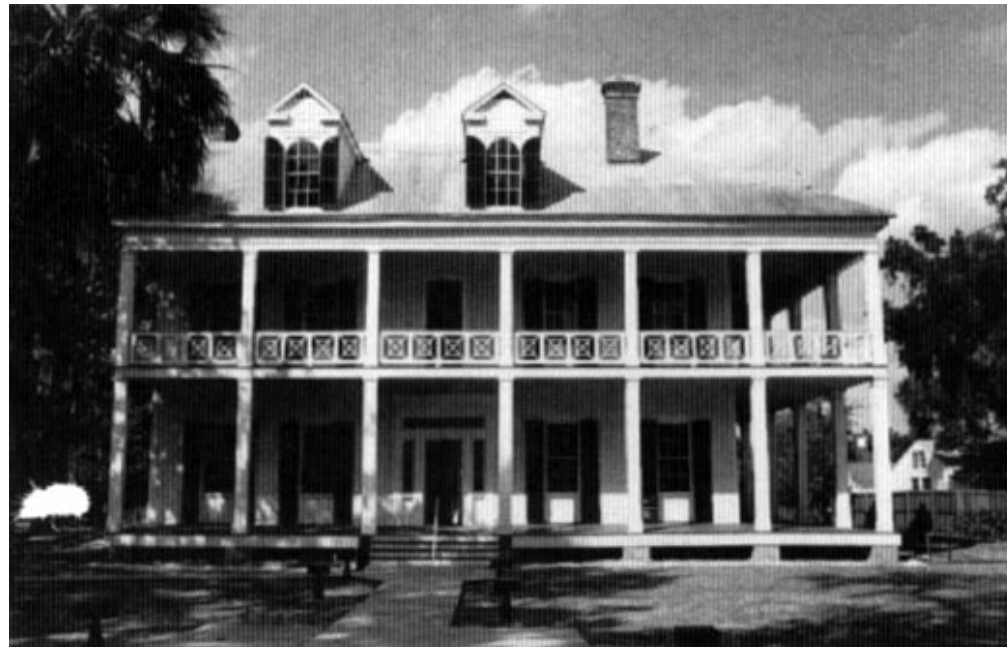
*The Bronson-Mulholland House in Palatka, Florida, ca. 1845, is shown (a) before and (b) after the treatment, Restoration. Over the years the east (far right) side of the veranda had been filled in as a sixth bay. During the restoration, this later infill was removed and the east veranda, together with its flooring, stairs, and foundation, restored. Photo: City of Palatka, Community Development Department.*
